**PROOF OF TYPE TESTING FOR VIESER POST INSTALLED SUPPORT RING**

The post installed support ring for floor gully extension was leak-tight in all relevant tests.

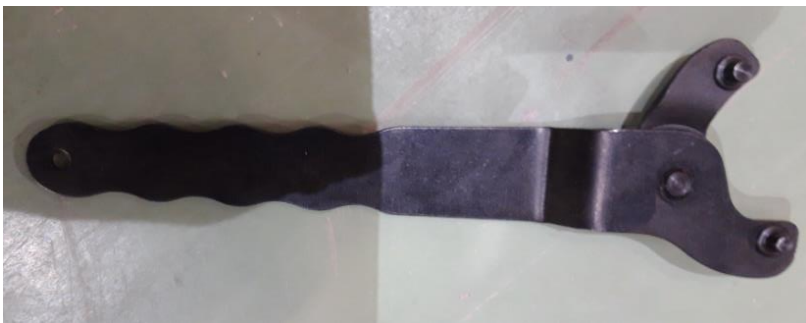
**Figure 1.** Customer delivered a tool for installing the post installed support ring.

Extension was installed to water gully with post installed support ring according to manufacturer's instruction. Figures 1 and 2 present the assembly and tools.

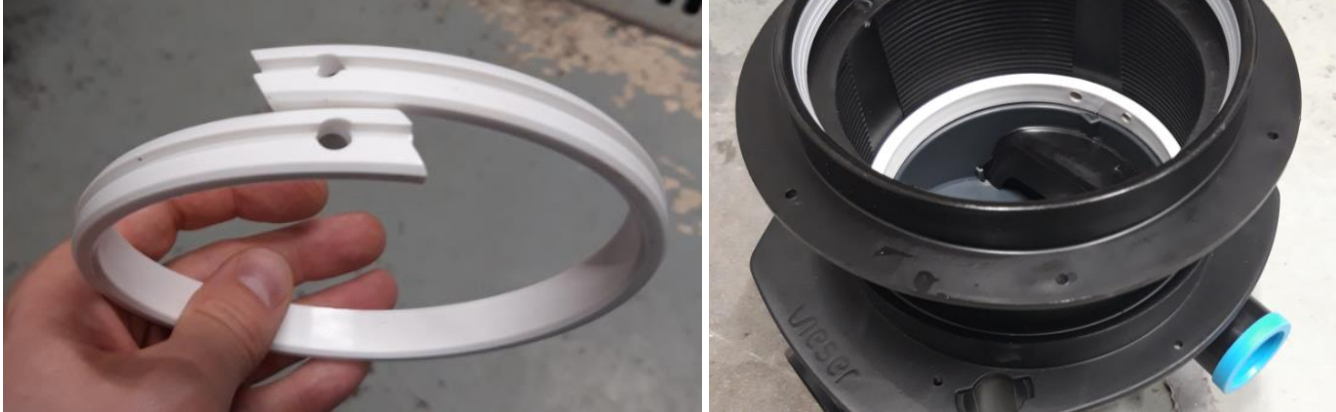
**Figure 2.** Uninstalled support ring in the left-hand side image. Assembled support ring, extension and floor gully in the right-hand image.
